New Meat Cooler Floor, Coating Packed into 4 Days

Case History

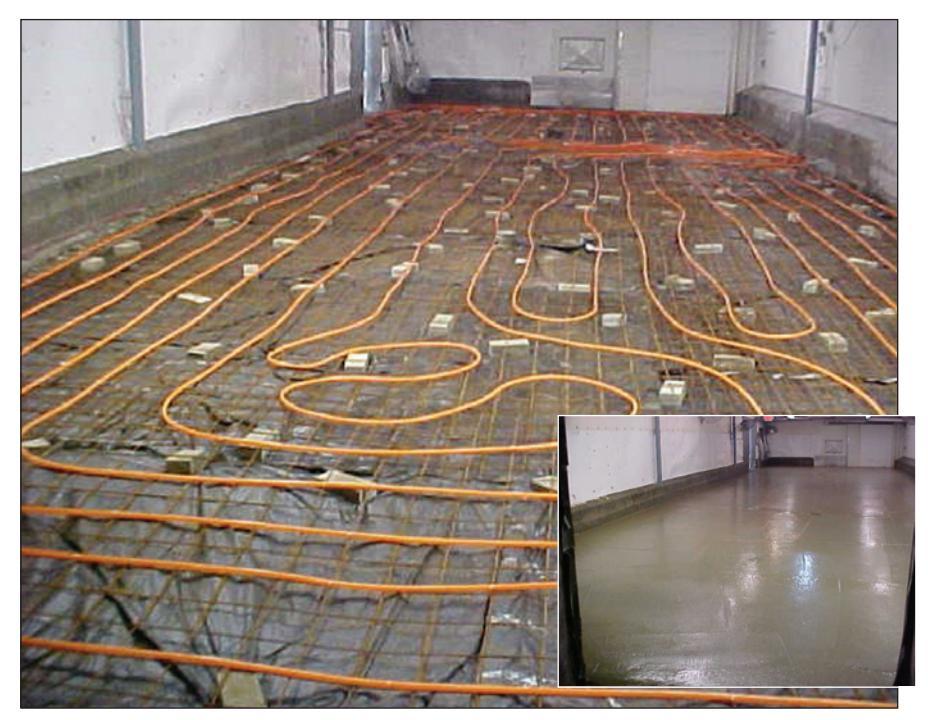
After removing the damaged concrete floor, the contractor's crew placed the heated tube system (above) and installed a new, four-inch concrete floor over the tubing (inset). Photos courtesy of Momence Packing Company

The contractor first broke up and removed the cooler's buckled concrete floor. A system of tubes that connect to the plant's boiler system formed a grid on the dirt base. The heated tubes are designed to keep the floor from undergoing thermal shock as a result of cycling from operating temperatures below freezing to high temperatures during hot water sanitizing. Maintained at 38 F (3 C), the floor cannot freeze and, therefore, cannot go through thermal shock, says Bob Smith, owner of the contracting company.

contractor installed the four-inch concrete floor. The concrete (a standard concrete mix with no admixtures to accelerate cure) was given a wood float finish, which imparts a little texture, says Smith. The next day, the contractor applied the 100% solids epoxy by hand troweling. "Typically, concrete requires a 28-day cure before flooring systems can be applied," says Smith. In contrast, the 100% solids epoxy can be applied over green concrete in as little as one day after concrete installation, he says. To prepare the concrete for coating, the contractor simply removed the watery slurry on the surface with brooms.
